# **SEGMENT ANALYSIS OF ONEIDA CREEK**

## **The Location of Sources of Pollution**

**Joseph C. Makarewicz and Theodore W. Lewis**

**September 2004**

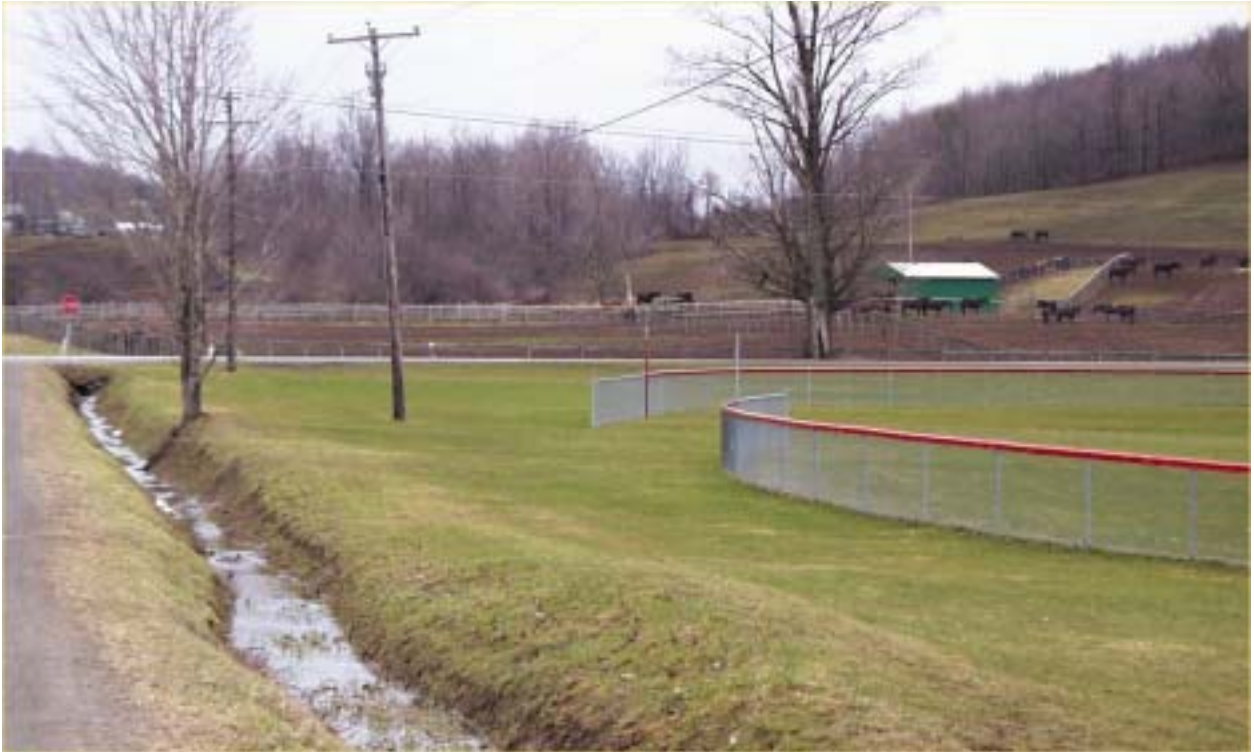
**Figure 7. Ditch that runs into a culvert at site 16. Note extensive area of exposed soil in pasture of grazing horses.**

site 16d by 526% and 482%, respectively. The horse farm was the most likely cause in the observed increase in April while construction practices were the major source in October.

3. Identified point and non-point sources of nutrients and solids can be remediated using Best Management Plans (BMPs). For example at site 16d, buffer strips near the culvert and rotational grazing pens are examples of how these effects can be minimized (See page 10 for some other examples). Also, it was quite clear that construction at the Morrisville Eaton Central School and at site 10b was not properly contained as large losses of soil were observed during one event. Better education of members of the community on construction practices is warranted.

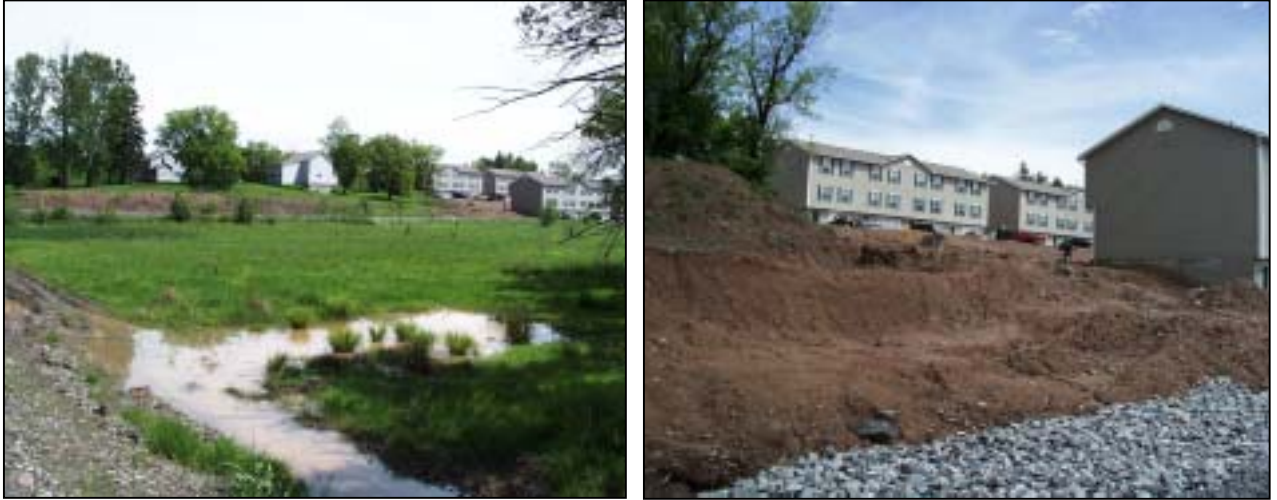
**Figure 10. Construction at site 10b showing exposed soil on a steep embankment and proximity of creek, 25 May 2004.**

Samples were limited to segment analysis on Taylor Creek. As a result of heavy rains (2.55 inches) during the previous evening, flow rates in Oneida Creek reached 1250 cubic feet per second at the U.S.G.S. Oneida gauging station. Several areas within this segment were identified as having problems. A 100+% increase in total phosphorus (411 to 1,076  $\mu\text{g P/L}$ ) and total suspended solids (270 to 489 mg/L) was observed from site 10a downstream to site 10. Similarly, at site 10b, elevated levels of total phosphorus, total suspended solids and total

Kjeldahl nitrogen were observed from site 10b to site 10a. These increases in soil loss and the particulate phase of phosphorus was likely caused by exposed soil (Fig. 10) at a new housing development and the lack of management practices to prevent soil erosion near site 10b.
