Green Infrastructure Planning for Improved Stormwater Management in Central New York

Technical Report

**Central New York Regional Planning & Development Board
January 2012**

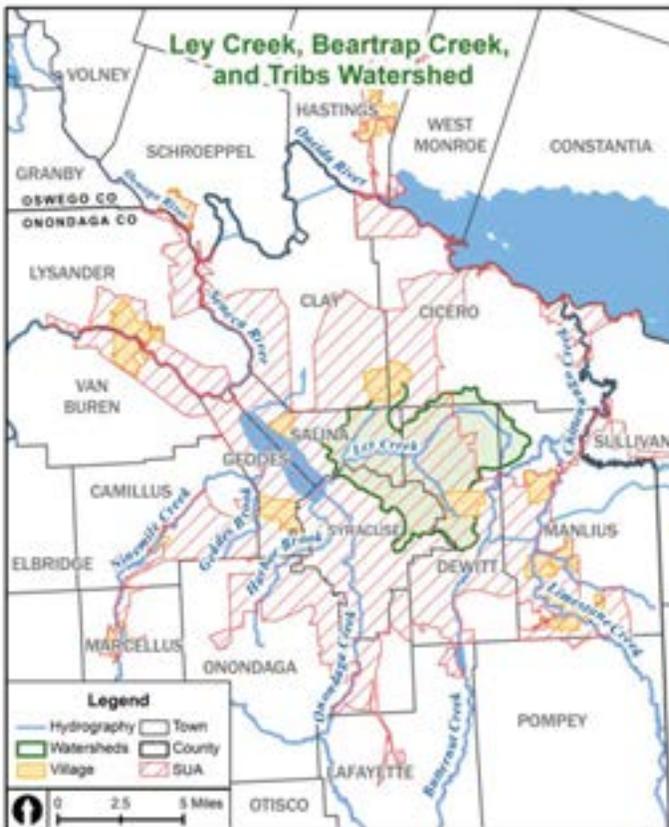
Ley Creek and Beartrap Creek Watershed

The watershed as a whole is very heavily developed and contains a mix of residential, commercial, and industrial uses. The gradient of Ley Creek and its tributaries is minimal throughout the watershed, and

elevation change as the main stem approaches Onondaga Lake is negligible, leading to significant flooding issues. Flooding is exacerbated by the fact that channelization of most of the length of the creek and tributaries has occurred, eliminating natural floodplain areas. Large quantities of impervious area throughout the watershed contribute to the total runoff volume. The use of green infrastructure practices to retrofit impervious areas has been identified as one way to reduce the impacts. However, in many cases, soil capacity to infiltrate stormwater is minimal due to poor drainage, and conveyance improvements would lead to minimum reduction of flooding due to the naturally low slope of the channels within the north and south branches of Ley Creek and other tributaries, including Sanders Creek and Beartrap Creek.

The high concentration of stormwater hotspots is responsible for introducing a host of pollutants to these streams. Use of the Simple Method model has shown that many of the drainage areas contributing to identified sites within the watershed exhibit high phosphorus and Total Suspended Solids loads on a per acre basis due to residential and commercial land use, respectively. Much of the development in the watershed is old and lacks stormwater runoff controls. Most of the developments do not have easements to allow access to the existing drainage systems, many of which are insufficient. Retrofit opportunities are limited due to the high preponderance of private property, but as redevelopment proposals occur, local planning boards should seize opportunities to incorporate green infrastructure and stormwater retrofits.

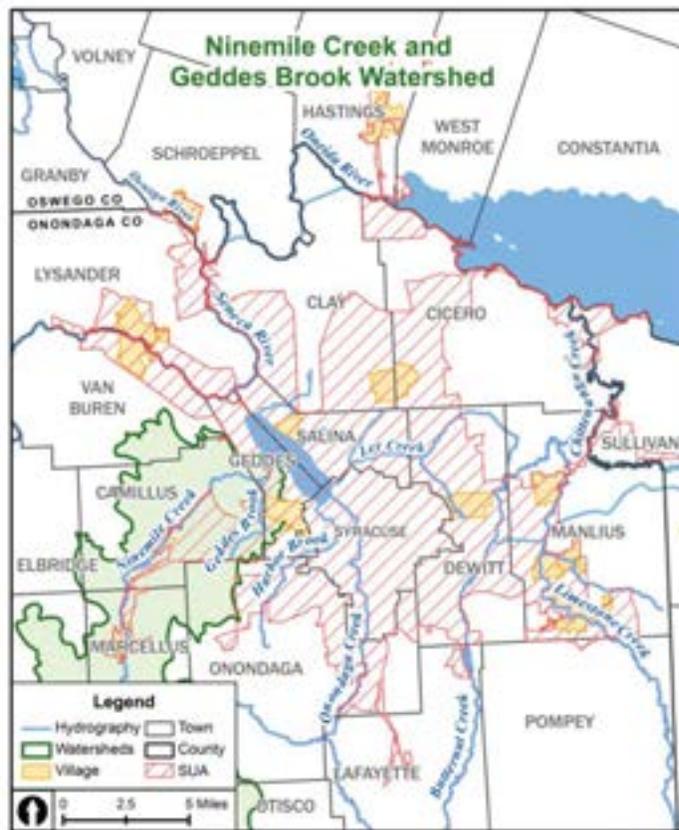
Ninemile Creek and Geddes Brook Watershed

Erosion and sediment input is one of the most significant problems in the Ninemile Creek watershed. This is of concern particularly due to the creek’s designation as a trout stream and its importance for recreational fishing. Development of steep hillsides in the watershed has led to formation of gullies and ravines within areas of open drainage. Channelization of streams and alteration of natural drainage patterns has, in some areas, led to flooding and erosion. Soils throughout many of the problem areas identified in this project are of good quality to allow infiltration. The potential to realize significant benefits through green infrastructure is significant in this watershed.

Issues that have been identified within the highly developed Geddes Brook portion of the Ninemile Creek watershed include (1) steep slopes with erodible soils, leading to introduction of large quantities of sediment to drainage systems, (2) use of closed conveyances (particularly in old neighborhoods and highly urbanized areas) with inadequate capacity to transport runoff, causing upstream bottlenecks that lead to localized flooding, and (3) locally high phosphorus loading from dense residential development within identified problem sewersheds, as modeled by the Simple Method. There are few easements and public lands to install retrofits that would correct these problems, but any opportunities that do exist should be utilized to the fullest extent possible. Erosion control on steep slopes should also be a high priority in the area.

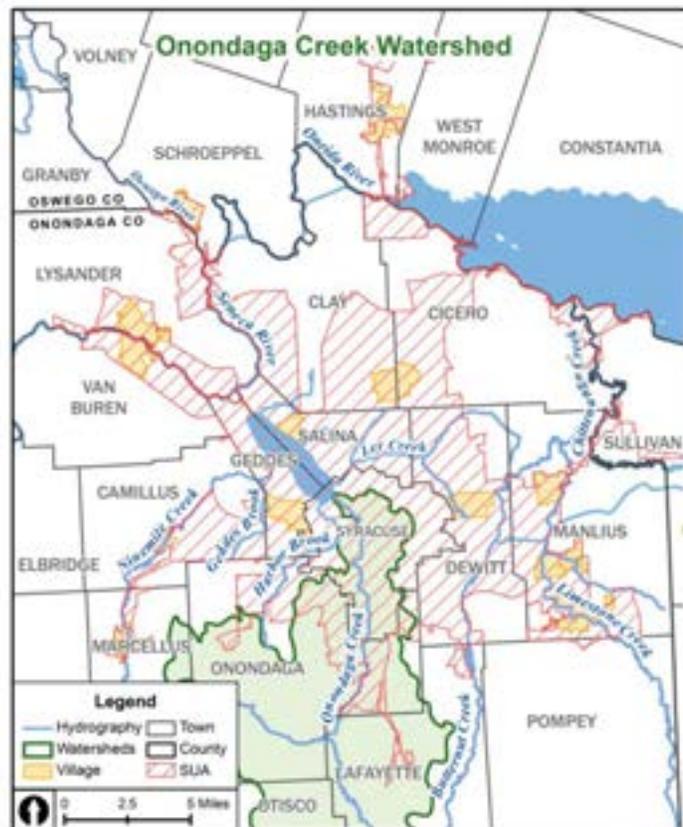
Onondaga Creek Watershed

The Onondaga Creek watershed contains hilly topography. Significant development (particularly residential) has occurred at both high and low elevations within the watershed. Localized flooding has resulted in areas that receive flow from the steeper, developed parts of the watershed. Portions of the watershed that contribute to problem areas contain some soils with good infiltration capacity; however, many of these areas occur on steep slopes. A significant proportion of the watershed is rural, and a key focus for Planning Boards should be to ensure that new development is protective of natural resources that play important roles in the hydrology of the watershed. New developments occurring in the upper (southern) parts of the watershed are generally low-density residential subdivisions with very large lots, often on former agricultural land. Potential high phosphorus and nitrogen loading from these developments is a concern.

The watershed is also impacted by the introduction of sediment from geologic phenomena known as mudboils, which occur in the upper (southern) part of the watershed. The mudboils introduce heavy loads of sediment to the stream that persist throughout its length, to the Inner Harbor of the City of Syracuse where Onondaga Creek meets Onondaga Lake. Combined sewer overflows in the City of Syracuse have historically led to flooding as well as the introduction of pathogens, nitrogen and phosphorus compounds, and floatables to Onondaga Creek. Onondaga County and the City of Syracuse are working with regulatory agencies to remedy these problems.

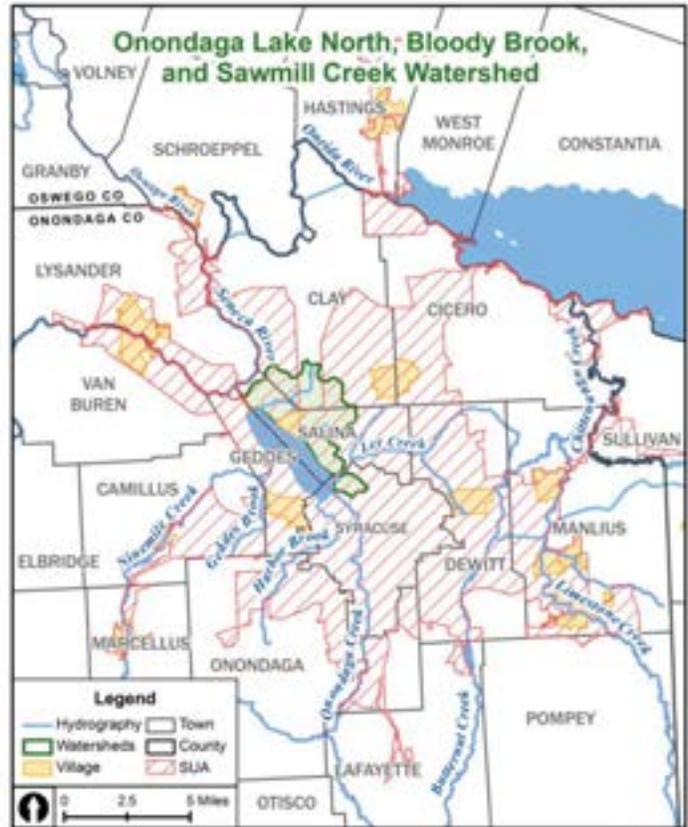
Bloody Brook and Sawmill Creek Watersheds and Direct Drainage to north side of Onondaga Lake

Areas along the north shore of Onondaga Lake are contained within Onondaga Lake Park, and are bordered by heavy residential and commercial development. Problems associated with this development include discharge of yard and foundation drains to Onondaga Lake, channelization and alteration of stream corridors to accommodate development, and inadequacy of existing stormwater management practices to fully address runoff volumes. Some of the subwatersheds modeled using the Simple Method reflect extremely high concentrations of Total Suspended Solids (TSS), attributed to commercial land use or high phosphorus levels resulting from residential uses. The use of green infrastructure or retrofits of existing stormwater management practices could help to mitigate these problems. Aside from several opportunities on public land presented by Onondaga Lake Park, many of the possible green infrastructure opportunities in the area would likely require cooperation with private commercial land owners.

The watersheds of Sawmill Creek and Bloody Brook contain dense commercial and residential development. Very high loading rates of both phosphorus and TSS are indicated by the Simple Method in some of the commercial areas studied. While soil characteristics are variable in these basins, the majority appear to be fair to poor for infiltration. Green infrastructure opportunities may be limited and should be utilized to maximum benefit where they are available.

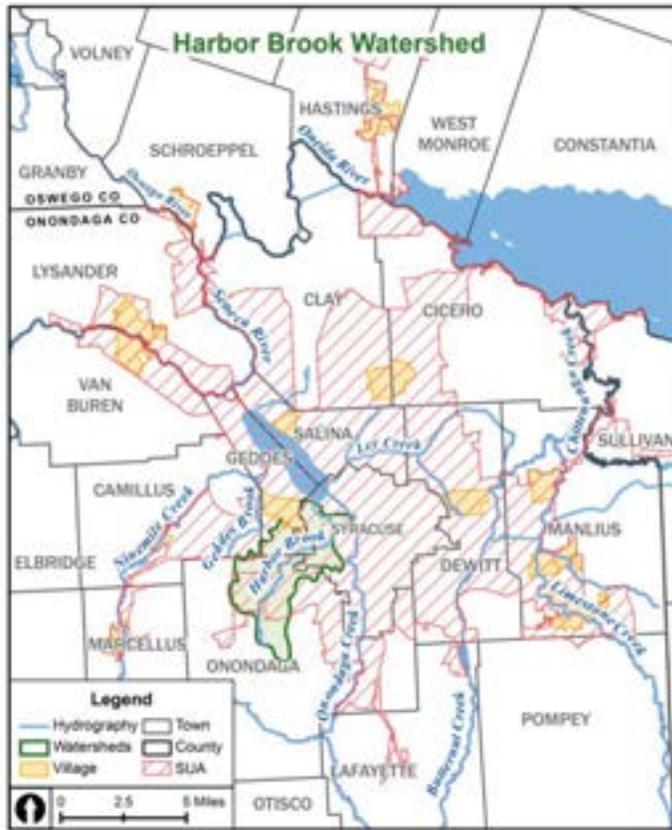
Harbor Brook Watershed

The watershed of Harbor Brook has been documented to contain drainage problems caused by the development of hillsides and steep slopes. Intense residential and commercial development is present in the lower portion of the Harbor Brook watershed, producing high phosphorus and TSS loads in some areas. Much of the drainage infrastructure in these areas is very old and in some cases, in need of retrofit due to capacity limitations and/or poor hydraulics. Unfortunately, few easements or public open spaces are available in these heavily urbanized areas. The introduction of impervious surface increases runoff from these areas, causing overload of existing conveyance systems and streams. Many of the existing conveyances consist of closed systems originating from mid-aged

to old developments, some of which are associated with combined sewers. Parts of the watershed also contain steep slopes on which erosion is occurring. In some cases, sediment from these slopes clogs closed drainage systems, creating localized flooding.

Impacts resulting from the erosion and sedimentation problems discussed above include the introduction of sediment, nutrients, and pathogens to Harbor Brook and its tributaries. Much of the watershed contains adequate soils to support infiltration, which may provide some mitigation of the problem, but this potential may be limited by steep slopes throughout the area. Combined sewer overflows in the City of Syracuse have historically led to flooding as well as the introduction of pathogens, nitrogen and phosphorus compounds, and floatables to Harbor Brook. Additionally, areas exist where roof downspout and foundation drainage is cross-connected to the sanitary sewer system, causing sanitary sewer overflows that discharge the same types of pollutants. Onondaga County and the City of Syracuse are working with regulatory agencies to remedy these problems.
